**Flood Control Project Maintenance
Levee Inspections**

Fall 2015 Levee Maintenance Deficiency Summary Report

Sutter Maintenance Yard Maintenance Area 0013

Waterway			Bank	Unit Miles
Unit No. 01 Cherokee Canal			Right	18.19
	Spring (March - May)	Summer (June - August)	(September - November) Fall	Winter (December - February)
Unit Maintenance Rating (Fall Only)			A	
Date of Inspection	05/06/2015 - 05/06/2015		11/06/2015 - 11/06/2015	
DWR Inspector	Bob Duffey		Bob Duffey	
Accompanied By	Shawn Freitag Sutter Maintenance Yard		Shawn Freitag Sutter Maintenance Yard

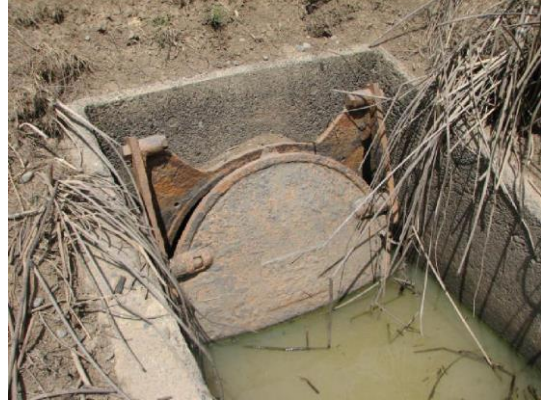
Photo 1 of 3 : UCIP_FA_2015_5269.jpg

Inspector Comments: FS_ID:46315
 DS_ID:16368
 EP_NO: N/A
 FS_HLM: 14.792
 Repair Type: Non-Urgent
 Crossing Status: Found
 UCIP Comments: 7/13/2015 Both sides of crossing were underwater at the time of inspection. Limited inspection on LS slope due to dense vegetation. Need photos of cleared WS & LS slopes. The flap gate is lodged open. 7/15/2013 Slopes have been cleared of vegetation and are in good condition. WS flapgate is still lodged open. 12/3/2013 Same as last inspection. 5/22/2014 Same as last inspection.
 FIELD_STRUCT_DESC: 36-inch corrugated metal drainpipe through the levee, 12.9 feet below the crown. Flap gate on the waterward end. Concrete "U" headwalls on both ends (USACE-1960). This entry matches the Drainage or Irrigation Structure referenced in O&M manual (HLM 14.79).
 FS Date: 07/17/2015

Headwall and flapgate located on water side of levee

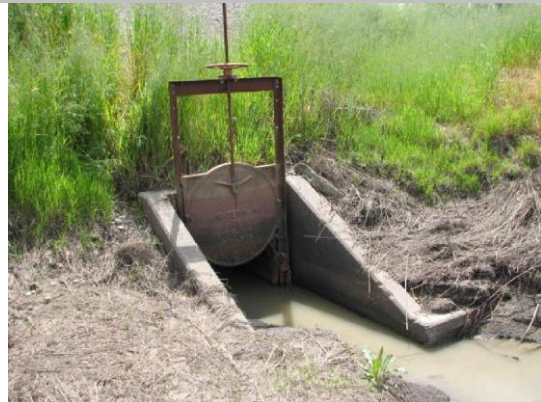
Photo 2 of 3 : UCIP_FA_2015_5270.jpg

Head wall and screw gate located on land side of levee

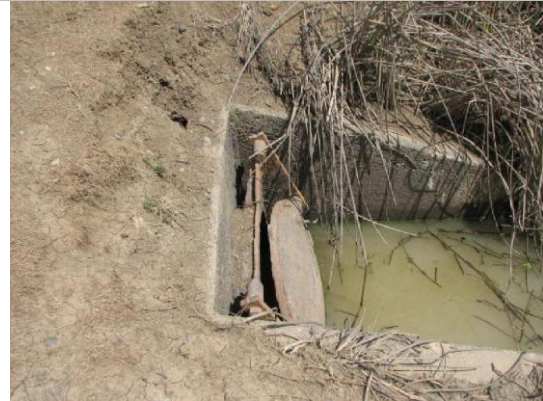
Photo 3 of 3 : UCIP_FA_2015_5271.jpg

LM Start	14.58	Rating **	M	Issue No.	69 (cont)
LM End	14.58	Issue Type +	En	Location *	WS
Category	Supplemental			GPS Latitude/Longitude	
				Start	End
Item	DWR UCIP Field Study			39.409481 °	39.409481 °
				-121.794010 °	-121.794010 °
DWR ID					
Action/Comments					
Inspector Comments: FS_ID:46315					
DS_ID:16368					
EP_NO: N/A					
FS_HLM: 14.792					
Repair Type: Non-Urgent					
Crossing Status: Found

Headwall and flapgate located on water side of levee

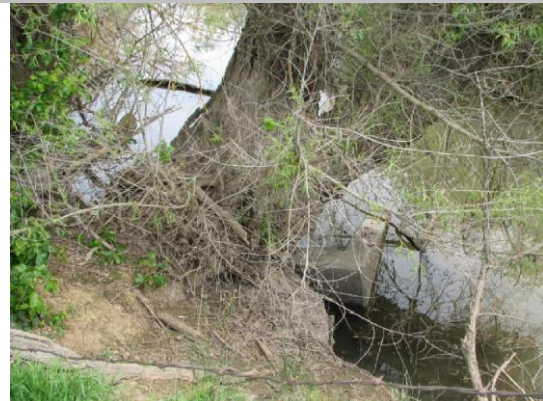
Photo 1 of 3 : UCIP_FA_2015_4709.jpg

LM Start	15.72	Rating **	U	Issue No.	70
LM End	15.72	Issue Type +	En	Location *	WS
Category	Supplemental			GPS Latitude/Longitude	
				Start	End
Item	DWR UCIP Field Study			39.399051 °	39.399051 °
				-121.810550 °	-121.810550 °
DWR ID					
Action/Comments					
Inspector Comments: FS_ID:46317					
DS_ID:16364					
EP_NO: 7521					
FS_HLM: 15.949					
Repair Type: Urgent					
Crossing Status: Found

View of headwall within channel.

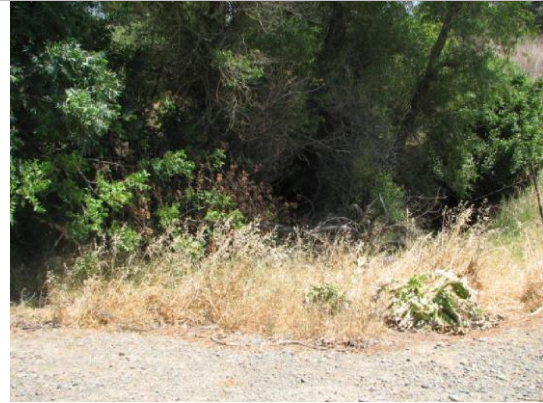
Photo 2 of 3 : UCIP_FA_2015_4710.jpg

Action/Comments					
Inspector Comments: FS_ID:46317 DS_ID:16364 EP_NO: 7521 FS_HLM: 15.949 Repair Type: Urgent Crossing Status: Found UCIP Comments: 7/13/2015 WS pipe end is heavily vegetated with trees and is making it almost impossible to inspect. Needs to be cleared out. LS appears in good condition.Limited inspection on WS and LS slopes/toe due to dense vegetation. Erosion behind headwall on WS toe. Need photos of cleared WS & LS slopes.7/15/2013 Slopes have been cleared of vegetation and are in good condition.12/3/2013 Same as last inspection.5/22/2014 Same as last inspection. FIELD_STRUCT_DESC: 30-inch corrugated metal drainpipe through the levee, 13.6 feet below the crown. Flap gate on the waterward end. Concrete "U" headwalls on both ends. A 48 inch corrugated metal standpipe located approximately 12 feet from landside levee toe. (Permit No. 7521-1972) FS Date: 07/17/2015

View of WS.

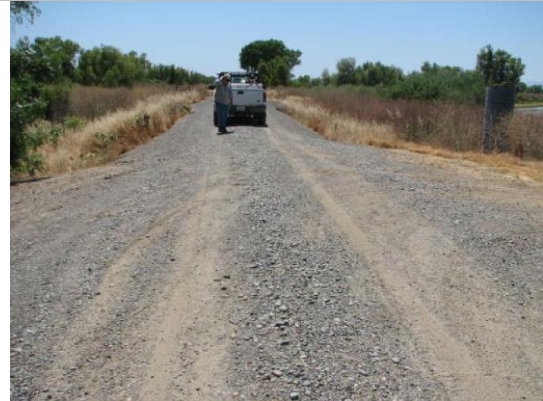
Photo 3 of 3 : UCIP_FA_2015_4711.jpg

Action/Comments					
Inspector Comments: FS_ID:46317 DS_ID:16364 EP_NO: 7521 FS_HLM: 15.949 Repair Type: Urgent Crossing Status: Found UCIP Comments: 7/13/2015 WS pipe end is heavily vegetated with trees and is making it almost impossible to inspect. Needs to be cleared out. LS appears in good condition. Limited inspection on WS and LS slopes/toe due to dense vegetation. Erosion behind headwall on WS toe. Need photos of cleared WS & LS slopes. 7/15/2013 Slopes have been cleared of vegetation and are in good condition. 12/3/2013 Same as last inspection. 5/22/2014 Same as last inspection. FIELD_STRUCT_DESC: 30-inch corrugated metal drainpipe through the levee, 13.6 feet below the crown. Flap gate on the waterward end. Concrete "U" headwalls on both ends. A 48 inch corrugated metal standpipe located approximately 12 feet from landside levee toe. (Permit No. 7521-1972) FS Date: 07/17/2015

Overview of levee crown at crossing looking downstream.

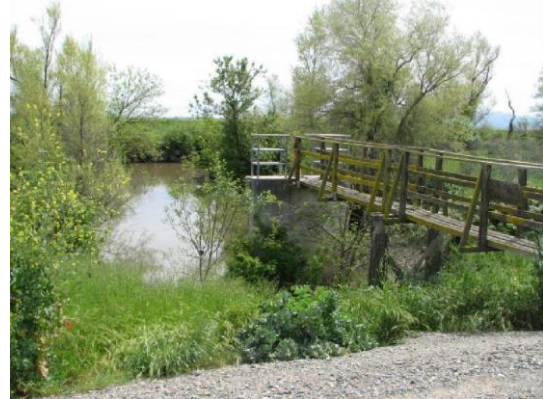
Photo 1 of 3 : UCIP_FA_2015_4712.jpg

Inspector Comments: FS_ID:46318
 DS_ID:16373
 EP_NO: 11805B
 FS_HLM: 15.992
 Repair Type: Non-Urgent
 Crossing Status: Found
 UCIP Comments: 7/13/2015 LS inlet still underwater. WS screwgate appears in good condition. Wooden walkway to the screwgate needs repairs. LS inlet is not visible-underwater. Limited inspection on WS and LS slope/toe due to dense vegetation. Need photos of cleared WS & LS slopes. 7/15/2013 Same as last inspection. 12/3/2013 Same as last inspection. 5/22/2014 Same as last inspection.
 FIELD_STRUCT_DESC: 48-inch diameter reinforced concrete pipe with six concrete collars through the levee, 14.4 feet below the crown to center of conduit. Slide gate, head-wall and wood walkway on two concrete piers on waterward side of levee. Revetment on waterward slope. Irrigation ditch on the landward side. (Permit No. 11805B-1979)
 FS Date: 07/17/2015

WS view of appurtenances (catwalk, slide gate, and headwall)

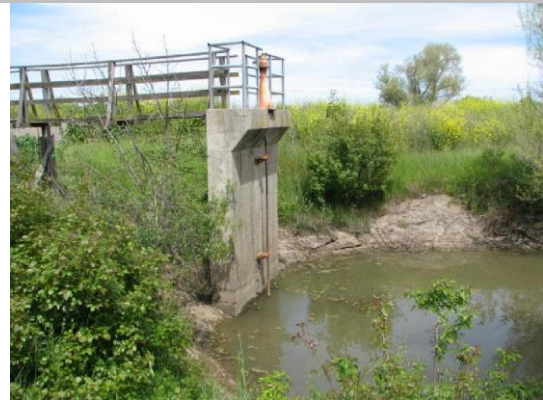
Photo 2 of 3 : UCIP_FA_2015_4713.jpg

WS view of catwalk, slide/screw gate, and headwall

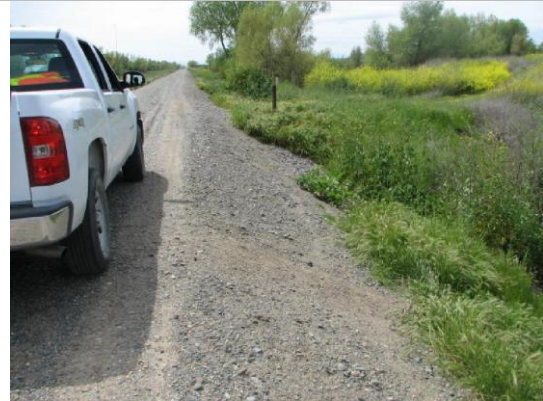
Photo 3 of 3 : UCIP_FA_2015_4714.jpg

LM Start	15.77	Rating **	M	Issue No.	71 (cont)
LM End	15.77	Issue Type +	En	Location *	WS
Category	Supplemental			GPS Latitude/Longitude	
				Start	End
Item	DWR UCIP Field Study			39.398615 °	39.398615 °
				-121.811250 °	-121.811250 °
DWR ID					
Action/Comments					
Inspector Comments: FS_ID:46318					
DS_ID:16373					
EP_NO: 11805B					
FS_HLM: 15.992					
Repair Type: Non-Urgent					
Crossing Status: Found

LS view of shoulder and slope.

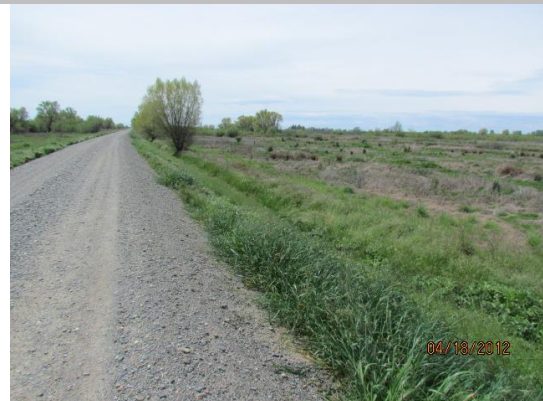
Photo 1 of 1 : FA_2015_MA0013_300_7_20150910_00004.jpg

LM Start	16.22	Rating **	M	Issue No.	7
LM End	17.17	Issue Type +	En	Location *	LS
Category	Earthen Levee			GPS Latitude/Longitude	
				Start	End
Item	Encroachments			39.394523 °	39.385580 °
				-121.817630 °	-121.831282 °
DWR ID	DWR_MA0013_01_s_2012_7				
Action/Comments					
Ditch

View of the agricultural along the toe of the levee.

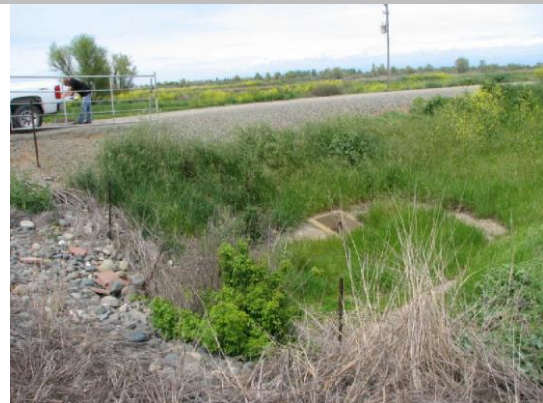
Photo 1 of 3 : UCIP_FA_2015_4805.jpg

LM Start	17.22	Rating **	M	Issue No.	73
LM End	17.22	Issue Type +	En	Location *	LS
Category	Supplemental			GPS Latitude/Longitude	
				Start	End
Item	DWR UCIP Field Study			39.385172 °	39.385172 °
				-121.832060 °	-121.832060 °
DWR ID					
Action/Comments					
Inspector Comments: FS_ID:46326 DS_ID:16369 EP_NO: N/A FS_HLM: 17.471 Repair Type: Non-Urgent Crossing Status: Found UCIP Comments: 7/13/2015 WS flap gate is blocked from opening by sediment. Needs to be dug out.Limited inspection on WS and LS slope due to dense vegetation and steep slopes. Need photos of cleared WS & LS slopes.7/15/2013 Slopes have been sprayed and cleared of vegetation and are in good condition. WS flapgate is blocked from opening by sediment buildup.12/3/2013 Sediment was dug out from WS flapgate allowing it to open.5/22/2014 Same as last inspection. FIELD_STRUCT_DESC: 24-inch corrugated metal drainpipe through the levee, 8.1 feet below the crown. Flap gate on the waterward side. Concrete "U" headwalls on both ends (USACE-1960). This entry matches the Drainage or Irrigation Structure referenced in O&M manual (HLM 17.47). FS Date: 07/20/2015

View of WS slope and toe.

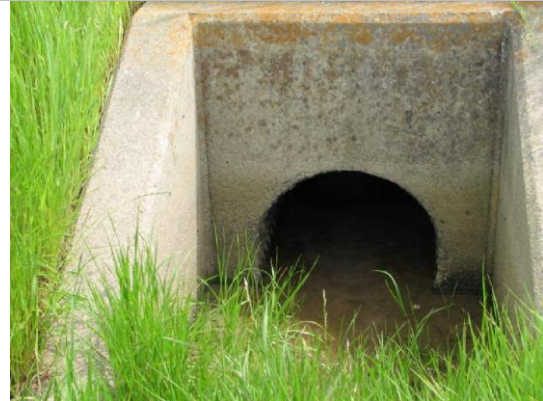
Photo 2 of 3 : UCIP_FA_2015_4806.jpg

Action/Comments					
Inspector Comments: FS_ID:46326 DS_ID:16369 EP_NO: N/A FS_HLM: 17.471 Repair Type: Non-Urgent Crossing Status: Found UCIP Comments: 7/13/2015 WS flap gate is blocked from opening by sediment. Needs to be dug out.Limited inspection on WS and LS slope due to dense vegetation and steep slopes. Need photos of cleared WS & LS slopes.7/15/2013 Slopes have been sprayed and cleared of vegetation and are in good condition. WS flapgate is blocked from opening by sediment buildup.12/3/2013 Sediment was dug out from WS flapgate allowing it to open.5/22/2014 Same as last inspection. FIELD_STRUCT_DESC: 24-inch corrugated metal drainpipe through the levee, 8.1 feet below the crown. Flap gate on the waterward side. Concrete "U" headwalls on both ends (USACE-1960). This entry matches the Drainage or Irrigation Structure referenced in O&M manual (HLM 17.47). FS Date: 07/20/2015

View of LS headwall.

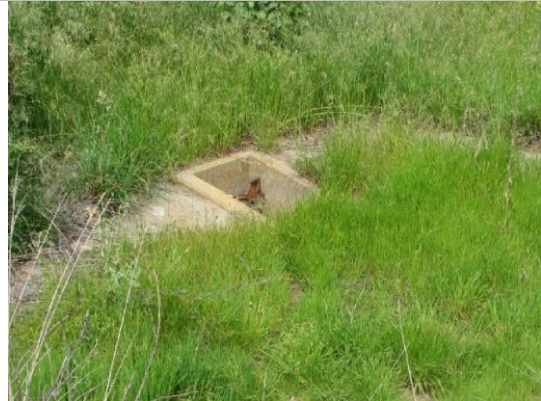
Photo 3 of 3 : UCIP_FA_2015_4807.jpg

Item	DWR UCIP Field Study			39.385172 °	39.385172 °	
				-121.832060 °	-121.832060 °	
DWR ID						
Action/Comments						
Inspector Comments: FS_ID:46326 DS_ID:16369 EP_NO: N/A FS_HLM: 17.471 Repair Type: Non-Urgent Crossing Status: Found UCIP Comments: 7/13/2015 WS flap gate is blocked from opening by sediment. Needs to be dug out.Limited inspection on WS and LS slope due to dense vegetation and steep slopes. Need photos of cleared WS & LS slopes.7/15/2013 Slopes have been sprayed and cleared of vegetation and are in good condition. WS flapgate is blocked from opening by sediment buildup.12/3/2013 Sediment was dug out from WS flapgate allowing it to open.5/22/2014 Same as last inspection. FIELD_STRUCT_DESC: 24-inch corrugated metal drainpipe through the levee, 8.1 feet below the crown. Flap gate on the waterward side. Concrete "U" headwalls on both ends (USACE-1960). This entry matches the Drainage or Irrigation Structure referenced in O&M manual (HLM 17.47). FS Date: 07/20/2015

View of WS headwall and flap gate.

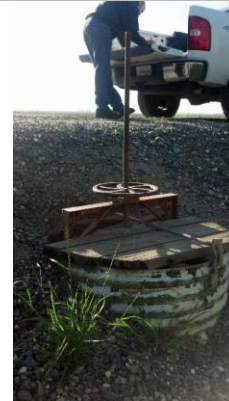
Photo 1 of 3 : UCIP_FA_2015_4832.jpg

LM Start	0.58	Rating **	M	Issue No.	912
LM End	0.58	Issue Type +	En	Location *	WS
Category	Supplemental			GPS Latitude/Longitude	
				Start	End
Item	DWR UCIP Field Study			39.566479 °	39.566479 °
				-121.702430 °	-121.702430 °
DWR ID					
Action/Comments					
Inspector Comments: FS_ID:46158 DS_ID:16398 EP_NO: N/A FS_HLM: 0.58 Repair Type: Non-Urgent Crossing Status: Found UCIP Comments: 7/1/2015 LS pipe end is still about 50% full of sediment.Need to fix the top of slide gate cover. The wooden cap on standpipe is broken. Limited evaluation of crossing due to dense vegetation on LS slope. Need photos of cleared slopes during fall inspection.7/10/2013 LS and WS slopes have been cleared of vegetation and are in good condition. LS pipe end is half full of sediment. Sediment inside of WS standpipe may hinder slide gate from fully closing. Standpipe cover is still broken.12/9/2013 Same as last inspection.5/29/2014 Same as last inspection. FIELD_STRUCT_DESC: 24-inch corrugated metal pipe through the levee, 10.6 feet below the crown. Slide gate in corrugated metal pipe riser on the waterward slope. Concrete "U" headwall on the landward side. 36-inch concrete standpipe in the channel with two wooden piles to deflect debris. (USACE-1962) This entry matches the Drainage or Irrigation Structure referenced in O&M manual (HLM 0.57). FS Date: 07/07/2015

Screw gate located on WS of levee. Screw gate covers needs to be repaired.

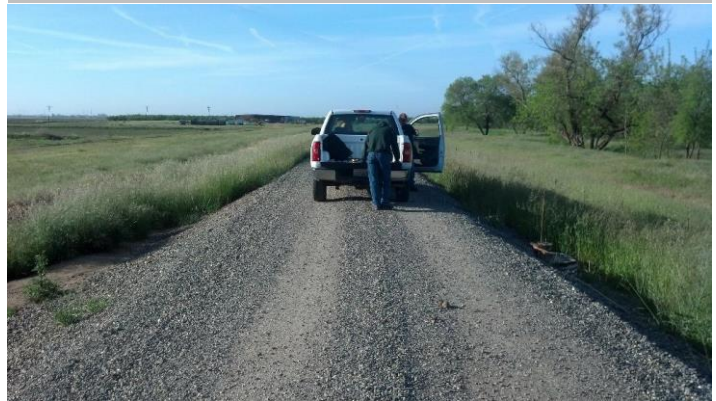
Photo 2 of 3 : UCIP_FA_2015_4833.jpg

UCIP Comments: 7/1/2015 LS pipe end is still about 50% full of sediment. Need to fix the top of slide gate cover. The wooden cap on standpipe is broken. Limited evaluation of crossing due to dense vegetation on LS slope. Need photos of cleared slopes during fall inspection. 7/10/2013 LS and WS slopes have been cleared of vegetation and are in good condition. LS pipe end is half full of sediment. Sediment inside of WS standpipe may hinder slide gate from fully closing. Standpipe cover is still broken. 12/9/2013 Same as last inspection. 5/29/2014 Same as last inspection.

Overview looking south

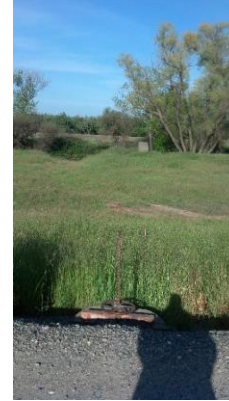
Photo 3 of 3 : UCIP_FA_2015_4834.jpg

View of WS slope and toe.

Action/Comments					
Inspector Comments: FS_ID:46158 DS_ID:16398 EP_NO: N/A FS_HLM: 0.58 Repair Type: Non-Urgent Crossing Status: Found UCIP Comments: 7/1/2015 LS pipe end is still about 50% full of sediment. Need to fix the top of slide gate cover. The wooden cap on standpipe is broken. Limited evaluation of crossing due to dense vegetation on LS slope. Need photos of cleared slopes during fall inspection. 7/10/2013 LS and WS slopes have been cleared of vegetation and are in good condition. LS pipe end is half full of sediment. Sediment inside of WS standpipe may hinder slide gate from fully closing. Standpipe cover is still broken. 12/9/2013 Same as last inspection. 5/29/2014 Same as last inspection. FIELD_STRUCT_DESC: 24-inch corrugated metal pipe through the levee, 10.6 feet below the crown. Slide gate in corrugated metal pipe riser on the waterward slope. Concrete "U" headwall on the landward side. 36-inch concrete standpipe in the channel with two wooden piles to deflect debris. (USACE-1962) This entry matches the Drainage or Irrigation Structure referenced in O&M manual (HLM 0.57). FS Date: 07/07/2015

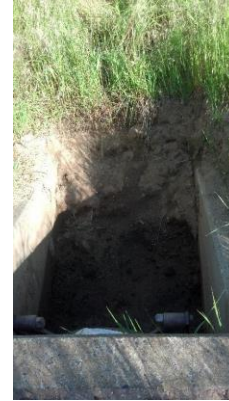
Photo 1 of 3 : UCIP_FA_2015_4951.jpg

View of WS toe.

Action/Comments					
<p>Inspector Comments: FS_ID:46160 DS_ID:16399 EP_NO: N/A FS_HLM: 1.71 Repair Type: Non-Urgent Crossing Status: Found UCIP Comments: 7/1/2015 LS screw gate frame is still twisted and hindering the gate from opening. Limited inspection dense vegetation on WS. Need photos of clear WS slope & toe. Ditch present in channel? This crossing was listed in the USACE Periodic Inspection report as Corp's Inspect ID# USACE_CESPK_M13G_2011_p_0108 for WS flap gate filled with soil and LS gate not functioning because of overgrown vegetation. 7/10/2013 WS slope is cleared of vegetation and is in good condition. LS screw gate frame is twisted and is preventing the gate from opening. 12/9/2013 Same as last inspection. 5/29/2014 Same as last inspection. FIELD_STRUCT_DESC: 24-inch CM drainage pipe through the levee, 7.9 feet below the crown. Flap gate on the waterward end. Concrete "U" headwalls on both ends. Slide gate at the landward toe in headwall (USACE-1960). This entry matches the Drainage or Irrigation Structure referenced in O&M manual (HLM 1.70). In 1962, permit number 3953 was issued for existing pump structure, intake box, ditch and power pole. In 1963, the pump and intake box were removed. FS Date: 07/07/2015</p>

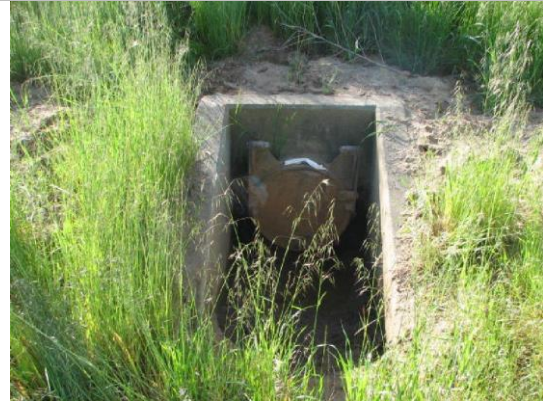
Photo 2 of 3 : UCIP_FA_2015_4952.jpg

Inspector Comments: FS_ID:46160
 DS_ID:16399
 EP_NO: N/A
 FS_HLM: 1.71
 Repair Type: Non-Urgent
 Crossing Status: Found
 UCIP Comments: 7/1/2015 LS screw gate frame is still twisted and hindering the gate from opening. Limited inspection dense vegetation on WS. Need photos of clear WS slope & toe. Ditch present in channel? This crossing was listed in the USACE Periodic Inspection report as Corp's Inspect ID# USACE_CESPK_M13G_2011_p_0108 for WS flap gate filled with soil and LS gate not functioning because of overgrown vegetation. 7/10/2013 WS slope is cleared of vegetation and is in good condition. LS screw gate frame is twisted and is preventing the gate from opening. 12/9/2013 Same as last inspection. 5/29/2014 Same as last inspection.
 FIELD_STRUCT_DESC: 24-inch CM drainage pipe through the levee, 7.9 feet below the crown. Flap gate on the waterward end. Concrete "U" headwalls on both ends. Slide gate at the landward toe in headwall (USACE-1960). This entry matches the Drainage or Irrigation Structure referenced in O&M manual (HLM 1.70). In 1962, permit number 3953 was issued for existing pump structure, intake box, ditch and power pole. In 1963, the pump and intake box were removed.

View of flap gate on WS.

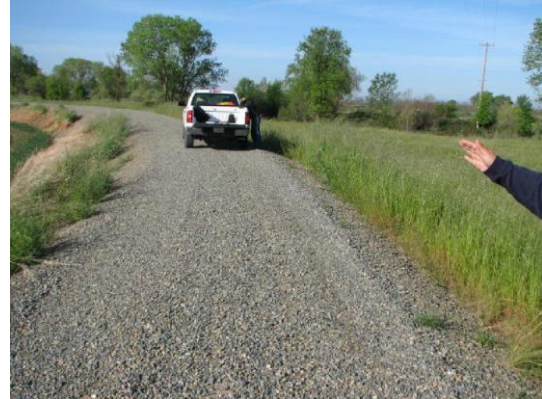
Photo 3 of 3 : UCIP_FA_2015_4953.jpg

Action/Comments					
Inspector Comments: FS_ID:46160 DS_ID:16399 EP_NO: N/A FS_HLM: 1.71 Repair Type: Non-Urgent Crossing Status: Found UCIP Comments: 7/1/2015 LS screw gate frame is still twisted and hindering the gate from opening. Limited inspection dense vegetation on WS. Need photos of clear WS slope & toe. Ditch present in channel? This crossing was listed in the USACE Periodic Inspection report as Corp's Inspect ID# USACE_CESPK_M13G_2011_p_0108 for WS flap gate filled with soil and LS gate not functioning because of overgrown vegetation. 7/10/2013 WS slope is cleared of vegetation and is in good condition. LS screw gate frame is twisted and is preventing the gate from opening. 12/9/2013 Same as last inspection. 5/29/2014 Same as last inspection. FIELD_STRUCT_DESC: 24-inch CM drainage pipe through the levee, 7.9 feet below the crown. Flap gate on the waterward end. Concrete "U" headwalls on both ends. Slide gate at the landward toe in headwall (USACE-1960). This entry matches the Drainage or Irrigation Structure referenced in O&M manual (HLM 1.70). In 1962, permit number 3953 was issued for existing pump structure, intake box, ditch and power pole. In 1963, the pump and intake box were removed. FS Date: 07/07/2015

Overview of crossing

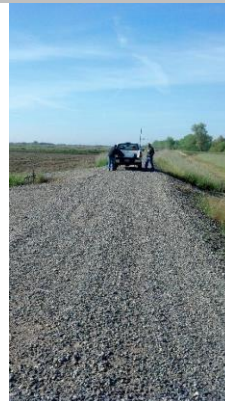
Photo 1 of 3 : UCIP_FA_2015_4954.jpg

Action/Comments					
Inspector Comments: FS_ID:46161 DS_ID:16400 EP_NO: N/A FS_HLM: 2.55 Repair Type: Non-Urgent Crossing Status: Found UCIP Comments: 7/1/2015 New screwgate installed on the LS. WS flapgate is still blocked from opening by sediment. Handle missing on slide gate. 7/10/2013 Sediment is built up against WS flap gate not allowing it to open. Handle for LS slide gate is still missing. 12/9/2013 Same as last inspection. 5/29/2014 Same as last inspection. FIELD_STRUCT_DESC: 1 of 2: 36-inch corrugated metal pipes through the levee, 9.7 feet below the crown. Flap gate on the waterward end. Slide gate on the landward end. Concrete "U" headwalls on both ends (USACE-1960). This entry matches the Drainage or Irrigation Structure referenced in O&M manual (HLM 2.54). FS Date: 07/07/2015

Overview of levee crown looking south

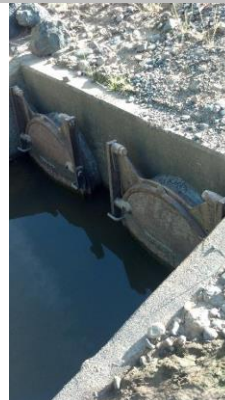
Photo 2 of 3 : UCIP_FA_2015_4955.jpg

Headwall and flap gates (2) located on water side of levee

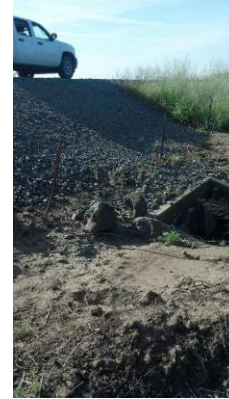
Photo 3 of 3 : UCIP_FA_2015_4956.jpg

LM Start	2.53	Rating **	M	Issue No.	914 (cont)
LM End	2.53	Issue Type +	En	Location *	WS
Category	Supplemental			GPS Latitude/Longitude	
				Start	End
Item	DWR UCIP Field Study			39.539195 °	39.539195 °
				-121.706070 °	-121.706070 °
DWR ID					
Action/Comments					
Inspector Comments: FS_ID:46161 DS_ID:16400 EP_NO: N/A FS_HLM: 2.55 Repair Type: Non-Urgent Crossing Status: Found

View of WS slope.

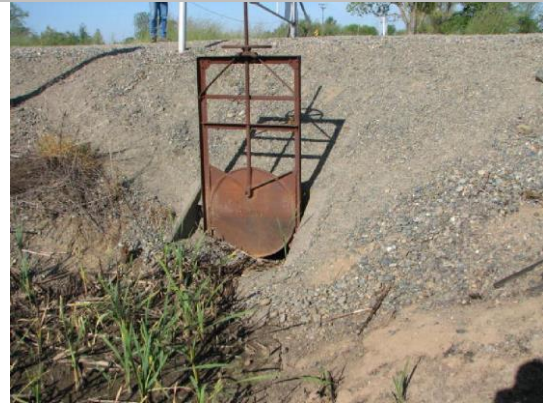
Photo 1 of 3 : UCIP_FA_2015_4343.jpg

LM Start	2.62	Rating **	M	Issue No.	915
LM End	2.62	Issue Type +	En	Location *	WS
Category	Supplemental			GPS Latitude/Longitude	
				Start	End
Item	DWR UCIP Field Study			39.537864 °	39.537864 °
				-121.706190 °	-121.706190 °
DWR ID					
Action/Comments					
Inspector Comments: FS_ID:46163 DS_ID:16402 EP_NO: N/A FS_HLM: 2.643 Repair Type: Non-Urgent Crossing Status: Found UCIP Comments: 7/1/2015 LS screwgate is still silted in and unable to be screwed down all the way. Needs to be cleaned out.Minor sediment built up on LS, remove sediment. Need photo of LS slide gate without sediment build up. This crossing was listed in the USACE Periodic Inspection report as Corp's inspect ID# USACE_CESPK_M13G_2011_p_0148 for LS gate obstructed by vegetation and WS flap gate is not functioning (propped open).7/10/2013 Same as last inspection.12/9/2013 WS flapgate was closed but LS slidegate is heavily vegetated and blocked from closing by sediment.5/29/2014 Same as last inspection. FIELD_STRUCT_DESC: 36-inch corrugated metal pipe through the levee, 8.8 feet below the crown. Flap gate on the waterward end. Slide gate on the landward end. Concrete "U" headwalls on both ends (USACE-1960). Structure used to drain water from Nelson Shippe Road. This entry matches the Drainage or Irrigation Structure referenced in O&M manual (HLM 2.63). FS Date: 07/07/2015

Headwall and screw gate located on land side of levee.

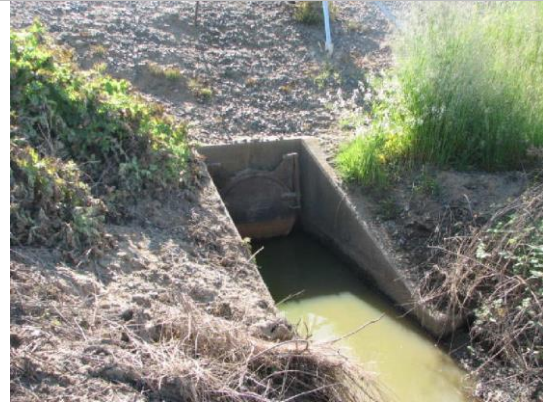
Photo 2 of 3 : UCIP_FA_2015_4957.jpg

LM Start	2.62	Rating **	M	Issue No.	915 (cont)
LM End	2.62	Issue Type +	En	Location *	WS
Category	Supplemental			GPS Latitude/Longitude	
				Start	End
Item	DWR UCIP Field Study			39.537864 °	39.537864 °
				-121.706190 °	-121.706190 °
DWR ID					
Action/Comments					
Inspector Comments: FS_ID:46163 DS_ID:16402 EP_NO: N/A FS_HLM: 2.643 Repair Type: Non-Urgent Crossing Status: Found UCIP Comments: 7/1/2015 LS screwgate is still silted in and unable to be screwed down all the way. Needs to be cleaned out.Minor sediment built up on LS, remove sediment. Need photo of LS slide gate without sediment build up. This crossing was listed in the USACE Periodic Inspection report as Corp's inspect ID# USACE_CESPK_M13G_2011_p_0148 for LS gate obstructed by vegetation and WS flap gate is not functioning (propped open).7/10/2013 Same as last inspection.12/9/2013 WS flapgate was closed but LS slidegate is heavily vegetated and blocked from closing by sediment.5/29/2014 Same as last inspection. FIELD_STRUCT_DESC: 36-inch corrugated metal pipe through the levee, 8.8 feet below the crown. Flap gate on the waterward end. Slide gate on the landward end. Concrete "U" headwalls on both ends (USACE-1960). Structure used to drain water from Nelson Shippe Road. This entry matches the Drainage or Irrigation Structure referenced in O&M manual (HLM 2.63). FS Date: 07/07/2015

Headwall and flap gate located on water side of levee

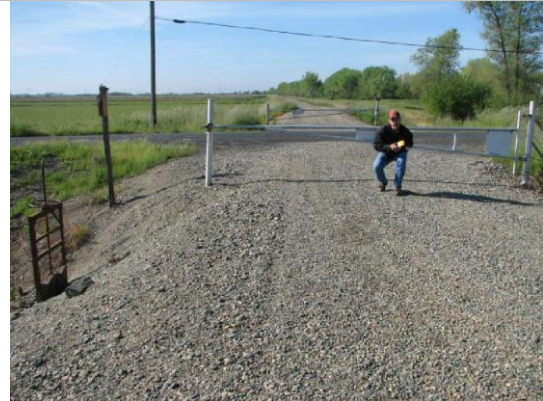
Photo 3 of 3 : UCIP_FA_2015_4958.jpg

Action/Comments					
Inspector Comments: FS_ID:46163 DS_ID:16402 EP_NO: N/A FS_HLM: 2.643 Repair Type: Non-Urgent Crossing Status: Found UCIP Comments: 7/1/2015 LS screwgate is still silted in and unable to be screwed down all the way. Needs to be cleaned out.Minor sediment built up on LS, remove sediment. Need photo of LS slide gate without sediment build up. This crossing was listed in the USACE Periodic Inspection report as Corp's inspect ID# USACE_CESPK_M13G_2011_p_0148 for LS gate obstructed by vegetation and WS flap gate is not functioning (propped open).7/10/2013 Same as last inspection.12/9/2013 WS flapgate was closed but LS slidegate is heavily vegetated and blocked from closing by sediment.5/29/2014 Same as last inspection. FIELD_STRUCT_DESC: 36-inch corrugated metal pipe through the levee, 8.8 feet below the crown. Flap gate on the waterward end. Slide gate on the landward end. Concrete "U" headwalls on both ends (USACE-1960). Structure used to drain water from Nelson Shippe Road. This entry matches the Drainage or Irrigation Structure referenced in O&M manual (HLM 2.63). FS Date: 07/07/2015

Overview looking south from left levee

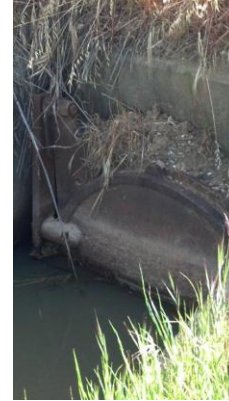
Photo 1 of 3 : UCIP_FA_2015_3199.jpg

Action/Comments					
Inspector Comments: FS_ID:46204 DS_ID:16403 EP_NO: N/A FS_HLM: 2.656 Repair Type: Non-Urgent Crossing Status: Found UCIP Comments: 7/1/2015 WS flap gate is partially blocked by sediment and needs to be cleaned. Burrowing holes located above WS headwall. Limited inspection on WS and LS slopes due to dense vegetation. Need photos of cleared WS & LS slopes. 7/10/2013 LS and WS slopes have been cleared of vegetation and are in good condition. 12/9/2013 Same as last inspection. 5/29/2014 Same as last inspection. FIELD_STRUCT_DESC: 36-inch corrugated metal pipe through the levee, 8.7 feet below the crown. Flap gate on the waterward end. Slide gate on landward end. Concrete "U" headwalls on both ends (USACE-1960). This entry matches the Drainage or Irrigation Structure referenced in O&M manual (HLM 2.65). FS Date: 07/16/2015

Headwall and flap gate located on WS

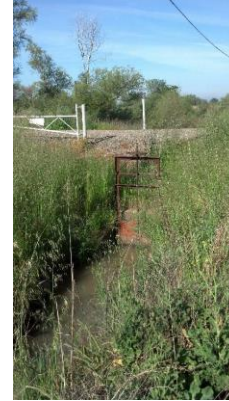
Photo 2 of 3 : UCIP_FA_2015_3200.jpg

Action/Comments					
Inspector Comments: FS_ID:46204 DS_ID:16403 EP_NO: N/A FS_HLM: 2.656 Repair Type: Non-Urgent Crossing Status: Found UCIP Comments: 7/1/2015 WS flap gate is partially blocked by sediment and needs to be cleaned. Burrowing holes located above WS headwall. Limited inspection on WS and LS slopes due to dense vegetation. Need photos of cleared WS & LS slopes. 7/10/2013 LS and WS slopes have been cleared of vegetation and are in good condition. 12/9/2013 Same as last inspection. 5/29/2014 Same as last inspection. FIELD_STRUCT_DESC: 36-inch corrugated metal pipe through the levee, 8.7 feet below the crown. Flap gate on the waterward end. Slide gate on landward end. Concrete "U" headwalls on both ends (USACE-1960). This entry matches the Drainage or Irrigation Structure referenced in O&M manual (HLM 2.65). FS Date: 07/16/2015

Headwall and screw gate located on the LS

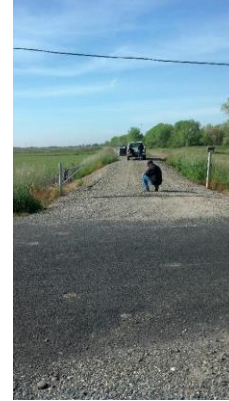
Photo 3 of 3 : UCIP_FA_2015_3201.jpg

LM Start	2.63	Rating **	M	Issue No.	916 (cont)
LM End	2.63	Issue Type +	En	Location *	WS
Category	Supplemental			GPS Latitude/Longitude	
				Start	End
Item	DWR UCIP Field Study			39.537671 °	39.537671 °
				-121.706210 °	-121.706210 °
DWR ID					
Action/Comments					
Inspector Comments: FS_ID:46204 DS_ID:16403 EP_NO: N/A FS_HLM: 2.656 Repair Type: Non-Urgent Crossing Status: Found UCIP Comments: 7/1/2015 WS flap gate is partially blocked by sediment and needs to be cleaned.Burrowing holes located above WS headwall. Limited inspection on WS and LS slopes due to dense vegetation. Need photos of cleared WS & LS slopes.7/10/2013 LS and WS slopes have been cleared of vegetation and are in good condition.12/9/2013 Same as last inspection.5/29/2014 Same as last inspection. FIELD_STRUCT_DESC: 36-inch corrugated metal pipe through the levee, 8.7 feet below the crown. Flap gate on the waterward end. Slide gate on landward end. Concrete "U" headwalls on both ends (USACE-1960). This entry matches the Drainage or Irrigation Structure referenced in O&M manual (HLM 2.65). FS Date: 07/16/2015

Overview at levee crown looking south

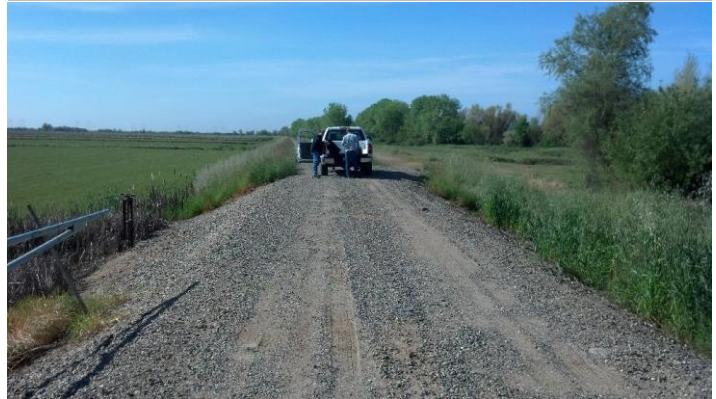
Photo 1 of 3 : UCIP_FA_2015_3202.jpg

Inspector Comments: FS_ID:46206
 DS_ID:16415
 EP_NO: N/A
 FS_HLM: 2.671
 Repair Type: Non-Urgent
 Crossing Status: Found
 UCIP Comments: 7/1/2015 WS flap gate is partially held open by sediment and needs to be dug out to allow it to fully close. 7/10/2013 LS and WS slopes are in good condition. Both LS and WS gates were fully submerged in water and unable to be inspected. 12/9/2013 Both gates were out of water and in good condition. 5/29/2014 Same as last inspection.
 FIELD_STRUCT_DESC: 36-inch corrugated metal pipe through the levee, 9.0 feet below the crown. Flap gate on the waterward end. Slide gate on the landward side. Concrete "U" headwall on both ends (USACE-1960). This entry matches the Drainage or Irrigation Structure referenced in O&M manual (HLM 2.66).
 FS Date: 07/16/2015

Overview looking south from left levee

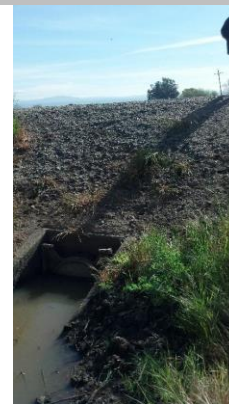
Photo 2 of 3 : UCIP_FA_2015_3203.jpg

Headwall and flap gate located on water side of levee

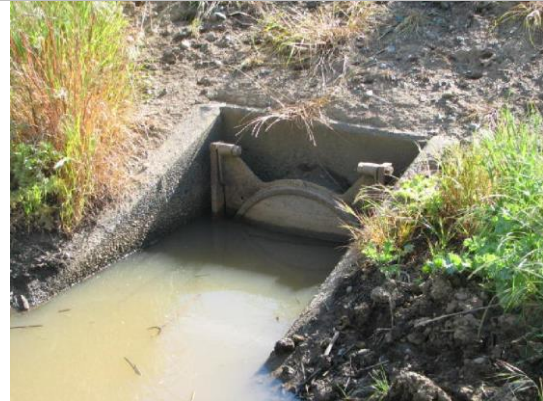
Photo 3 of 3 : UCIP_FA_2015_3204.jpg

LM Start	2.65	Rating **	M	Issue No.	917 (cont)
LM End	2.65	Issue Type +	En	Location *	WS
Category	Supplemental			GPS Latitude/Longitude	
				Start	End
Item	DWR UCIP Field Study			39.537466 °	39.537466 °
				-121.706240 °	-121.706240 °
DWR ID					
Action/Comments					
Inspector Comments: FS_ID:46206					
DS_ID:16415					
EP_NO: N/A					
FS_HLM: 2.671					
Repair Type: Non-Urgent					
Crossing Status: Found

WS headwall and flap gate.

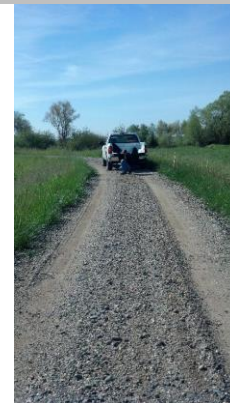
Photo 1 of 3 : UCIP_FA_2015_3205.jpg

LM Start	3.59	Rating **	M	Issue No.	918
LM End	3.59	Issue Type +	En	Location *	WS
Category	Supplemental			GPS Latitude/Longitude	
				Start	End
Item	DWR UCIP Field Study			39.523829 °	39.523829 °
				-121.706290 °	-121.706290 °
DWR ID					
Action/Comments					
Inspector Comments: FS_ID:46207 DS_ID:16405 EP_NO: N/A FS_HLM: 3.624 Repair Type: Non-Urgent Crossing Status: Found UCIP Comments: 7/1/2015 Still a non functioning crossing. LS screw gate is completely buried by sediment with only part of its frame and stem visible. WS flapgate is blocked from opening by sediment and debris. Non-functioning crossing. Farmer uses pipe located at LM 3.682 to drain field & not this one. Dense vegetation-need photos of cleared WS & LS slopes. This crossing was listed in the USACE Periodic Inspection report as Corp's inspect ID# USACE_CESPK_M13G_2011_p_0172 for no access to WS gate due to high water & dense vegetation. 7/10/2013 LS and WS slopes have been cleared of vegetation and are in good condition. WS flap gate is out of water but is blocked from opening by sediment build up. LS gate is fully submerged and not able to be inspected. 12/9/2013 LS slide gate is completely buried by soil and WS flapgate is blocked from opening by sediment. Crossing appears abandoned and non-functional. 5/29/2014 Same as last inspection. FIELD_STRUCT_DESC: 36-inch corrugated metal pipe through the levee, 11.5 feet below the crown. Flap gate on the waterward end. Slide gate on the landward end. Concrete "U" headwalls on both ends (USACE-1960). This entry matches the Drainage or Irrigation Structure referenced in O&M manual (HLM 3.61) FS Date: 07/16/2015

Overview looking south from left levee

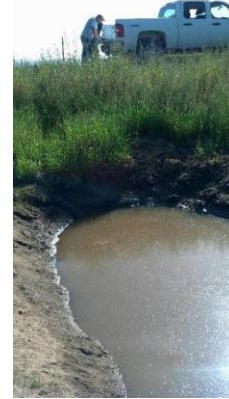
Photo 2 of 3 : UCIP_FA_2015_3206.jpg

Action/Comments					
<p>Inspector Comments: FS_ID:46207 DS_ID:16405 EP_NO: N/A FS_HLM: 3.624 Repair Type: Non-Urgent Crossing Status: Found UCIP Comments: 7/1/2015 Still a non functioning crossing. LS screw gate is completely buried by sediment with only part of its frame and stem visible. WS flapgate is blocked from opening by sediment and debris. Non-functioning crossing. Farmer uses pipe located at LM 3.682 to drain field & not this one. Dense vegetation-need photos of cleared WS & LS slopes. This crossing was listed in the USACE Periodic Inspection report as Corp's inspect ID# USACE_CESPK_M13G_2011_p_0172 for no access to WS gate due to high water & dense vegetation. 7/10/2013 LS and WS slopes have been cleared of vegetation and are in good condition. WS flap gate is out of water but is blocked from opening by sediment build up. LS gate is fully submerged and not able to be inspected. 12/9/2013 LS slide gate is completely buried by soil and WS flapgate is blocked from opening by sediment. Crossing appears abandoned and non-functional. 5/29/2014 Same as last inspection. FIELD_STRUCT_DESC: 36-inch corrugated metal pipe through the levee, 11.5 feet below the crown. Flap gate on the waterward end. Slide gate on the landward end. Concrete "U" headwalls on both ends (USACE-1960). This entry matches the Drainage or Irrigation Structure referenced in O&M manual (HLM 3.61) FS Date: 07/16/2015</p>

Flap gate submerged in water on WS of levee

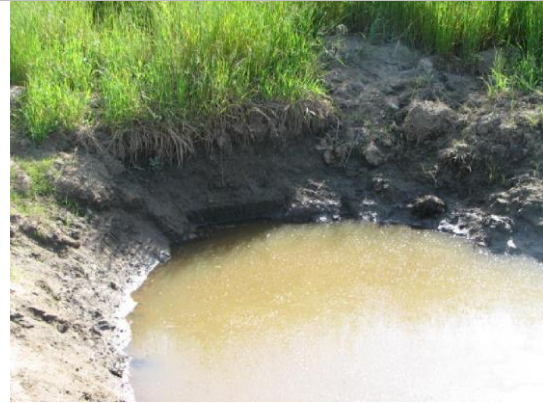
Photo 3 of 3 : UCIP_FA_2015_3207.jpg

Action/Comments					
Inspector Comments: FS_ID:46207 DS_ID:16405 EP_NO: N/A FS_HLM: 3.624 Repair Type: Non-Urgent Crossing Status: Found UCIP Comments: 7/1/2015 Still a non functioning crossing. LS screw gate is completely buried by sediment with only part of its frame and stem visible. WS flapgate is blocked from opening by sediment and debris. Non-functioning crossing. Farmer uses pipe located at LM 3.682 to drain field & not this one. Dense vegetation-need photos of cleared WS & LS slopes. This crossing was listed in the USACE Periodic Inspection report as Corp's inspect ID# USACE_CESPK_M13G_2011_p_0172 for no access to WS gate due to high water & dense vegetation. 7/10/2013 LS and WS slopes have been cleared of vegetation and are in good condition. WS flap gate is out of water but is blocked from opening by sediment build up. LS gate is fully submerged and not able to be inspected. 12/9/2013 LS slide gate is completely buried by soil and WS flapgate is blocked from opening by sediment. Crossing appears abandoned and non-functional. 5/29/2014 Same as last inspection. FIELD_STRUCT_DESC: 36-inch corrugated metal pipe through the levee, 11.5 feet below the crown. Flap gate on the waterward end. Slide gate on the landward end. Concrete "U" headwalls on both ends (USACE-1960). This entry matches the Drainage or Irrigation Structure referenced in O&M manual (HLM 3.61) FS Date: 07/16/2015

View of flap gate submerged on WS toe.

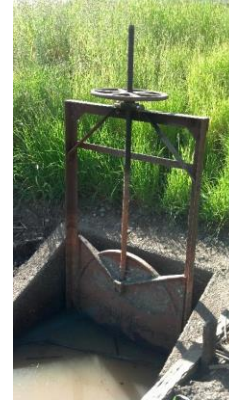
Photo 1 of 3 : UCIP_FA_2015_5109.jpg

Action/Comments					
Inspector Comments: FS_ID:46208 DS_ID:16848 EP_NO: N/A FS_HLM: 3.684 Repair Type: Non-Urgent Crossing Status: Found UCIP Comments: 7/1/2015 Both gates were still submerged in water. Levee slopes were in good condition. Dense vegetation makes it difficult to evaluate the condition of the LS slope. Both gates underwater. Recommend taking photos of clear slopes and gates during fall inspection. 7/10/2013 LS slope has been cleared of vegetation and is in good condition. Both gates are still underwater and not able to be inspected. 12/9/2013 Same as last inspection. 5/29/2014 Same as last inspection. FIELD_STRUCT_DESC: 36-inch corrugated metal pipe through levee, 9.2 feet below the crown. Flap gate on the waterward end. Slide gate on the landward end. Concrete "U" headwalls on both ends (USACE-1960). This entry matches the Drainage or Irrigation Structure referenced in O&M manual (HLM 3.67). FS Date: 07/16/2015

Headwall and screw gate located on land side of levee

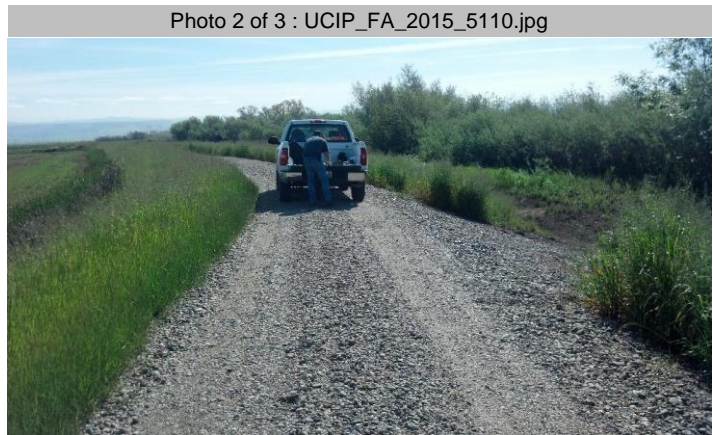
Item	DWR UCIP Field Study			39.523556 °	39.523556 °	
				-121.705340 °	-121.705340 °	
DWR ID						
Action/Comments						
Inspector Comments: FS_ID:46208 DS_ID:16848 EP_NO: N/A FS_HLM: 3.684 Repair Type: Non-Urgent Crossing Status: Found UCIP Comments: 7/1/2015 Both gates were still submerged in water. Levee slopes were in good condition. Dense vegetation makes it difficult to evaluate the condition of the LS slope. Both gates underwater. Recommend taking photos of clear slopes and gates during fall inspection. 7/10/2013 LS slope has been cleared of vegetation and is in good condition. Both gates are still underwater and not able to be inspected. 12/9/2013 Same as last inspection. 5/29/2014 Same as last inspection. FIELD_STRUCT_DESC: 36-inch corrugated metal pipe through levee, 9.2 feet below the crown. Flap gate on the waterward end. Slide gate on the landward end. Concrete "U" headwalls on both ends (USACE-1960). This entry matches the Drainage or Irrigation Structure referenced in O&M manual (HLM 3.67). FS Date: 07/16/2015

Overview looking south on left levee

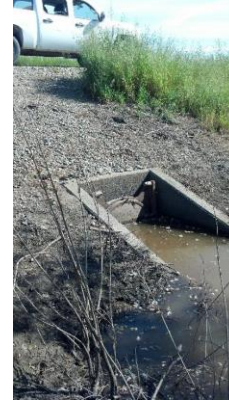
Photo 3 of 3 : UCIP_FA_2015_5111.jpg

Action/Comments					
Inspector Comments: FS_ID:46208 DS_ID:16848 EP_NO: N/A FS_HLM: 3.684 Repair Type: Non-Urgent Crossing Status: Found UCIP Comments: 7/1/2015 Both gates were still submerged in water. Levee slopes were in good condition. Dense vegetation makes it difficult to evaluate the condition of the LS slope. Both gates underwater. Recommend taking photos of clear slopes and gates during fall inspection. 7/10/2013 LS slope has been cleared of vegetation and is in good condition. Both gates are still underwater and not able to be inspected. 12/9/2013 Same as last inspection. 5/29/2014 Same as last inspection. FIELD_STRUCT_DESC: 36-inch corrugated metal pipe through levee, 9.2 feet below the crown. Flap gate on the waterward end. Slide gate on the landward end. Concrete "U" headwalls on both ends (USACE-1960). This entry matches the Drainage or Irrigation Structure referenced in O&M manual (HLM 3.67). FS Date: 07/16/2015

Headwall and flap gate located on water side of levee

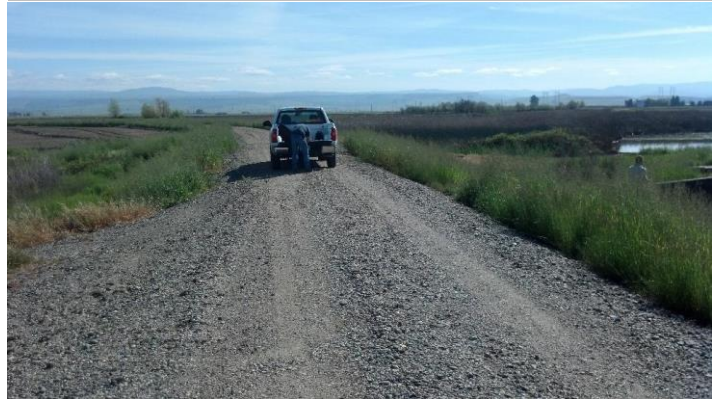
Photo 1 of 3 : UCIP_FA_2015_5112.jpg

Action/Comments					
Inspector Comments: FS_ID:46209					
DS_ID:16847					
EP_NO: N/A					
FS_HLM: 3.864					
Repair Type: Non-Urgent					
Crossing Status: Found					
UCIP Comments: 7/1/2015 There appears to be a LS gate now but both pipe ends were submerged so it was hard to tell for certain. LS gate missing & limited inspection. Need photos of WS & LS cleared slopes. Description calls for slide gate on LS-slide gate missing. Debris scattered near LS headwall. This crossing was listed in the USACE Periodic Inspection report as Corp's Inspect ID#					
USACE_CESPK_M13J_2011_p_0010 for WS gate wedged open & missing LS slide gate. 7/10/2013 WS and LS slopes have been cleared of vegetation and are in good condition. LS gate is still missing and WS flap gate is still wedged open with sticks. 12/9/2013 Pulled sticks from WS flap gate to allow it to close. LS gate is still missing. 5/29/2014 Same as last inspection.

FIELD_STRUCT_DESC: 36-inch corrugated metal pipe through the levee, 8.8 feet below the crown. Flap gate on the waterward end. Slide gate on the landward end. Concrete "U" headwalls on both ends (USACE-1960). This entry matches the Drainage or Irrigation Structure referenced in O&M manual (HLM 3.85).					
FS Date: 07/16/2015

Overview looking south on left levee

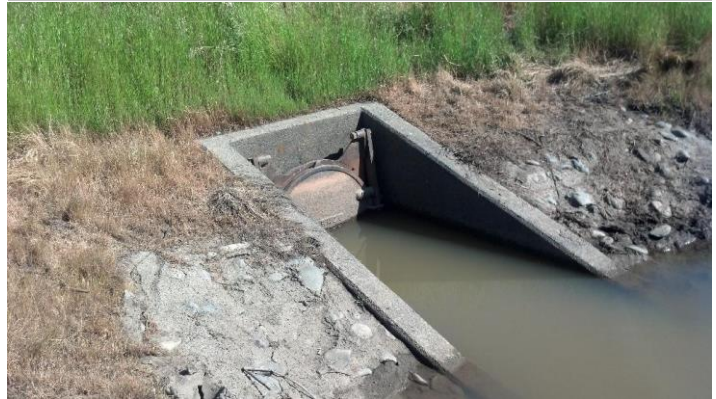
Photo 2 of 3 : UCIP_FA_2015_5113.jpg

Action/Comments					
Inspector Comments: FS_ID:46209 DS_ID:16847 EP_NO: N/A FS_HLM: 3.864 Repair Type: Non-Urgent Crossing Status: Found UCIP Comments: 7/1/2015 There appears to be a LS gate now but both pipe ends were submerged so it was hard to tell for certain. LS gate missing & limited inspection. Need photos of WS & LS cleared slopes. Description calls for slide gate on LS-slide gate missing. Debris scattered near LS headwall. This crossing was listed in the USACE Periodic Inspection report as Corp's Inspect ID# USACE_CESPK_M13J_2011_p_0010 for WS gate wedged open & missing LS slide gate. 7/10/2013 WS and LS slopes have been cleared of vegetation and are in good condition. LS gate is still missing and WS flap gate is still wedged open with sticks. 12/9/2013 Pulled sticks from WS flap gate to allow it to close. LS gate is still missing. 5/29/2014 Same as last inspection. FIELD_STRUCT_DESC: 36-inch corrugated metal pipe through the levee, 8.8 feet below the crown. Flap gate on the waterward end. Slide gate on the landward end. Concrete "U" headwalls on both ends (USACE-1960). This entry matches the Drainage or Irrigation Structure referenced in O&M manual (HLM 3.85). FS Date: 07/16/2015

Headwall and flap gate located on WS toe.

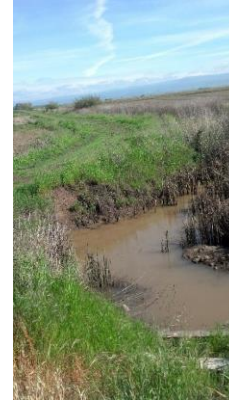
Photo 3 of 3 : UCIP_FA_2015_5114.jpg

Action/Comments					
Inspector Comments: FS_ID:46209 DS_ID:16847 EP_NO: N/A FS_HLM: 3.864 Repair Type: Non-Urgent Crossing Status: Found UCIP Comments: 7/1/2015 There appears to be a LS gate now but both pipe ends were submerged so it was hard to tell for certain. LS gate missing & limited inspection. Need photos of WS & LS cleared slopes. Description calls for slide gate on LS-slide gate missing. Debris scattered near LS headwall. This crossing was listed in the USACE Periodic Inspection report as Corp's Inspect ID# USACE_CESPK_M13J_2011_p_0010 for WS gate wedged open & missing LS slide gate. 7/10/2013 WS and LS slopes have been cleared of vegetation and are in good condition. LS gate is still missing and WS flap gate is still wedged open with sticks. 12/9/2013 Pulled sticks from WS flap gate to allow it to close. LS gate is still missing. 5/29/2014 Same as last inspection. FIELD_STRUCT_DESC: 36-inch corrugated metal pipe through the levee, 8.8 feet below the crown. Flap gate on the waterward end. Slide gate on the landward end. Concrete "U" headwalls on both ends (USACE-1960). This entry matches the Drainage or Irrigation Structure referenced in O&M manual (HLM 3.85). FS Date: 07/16/2015

View of channel at crossing looking D/S.

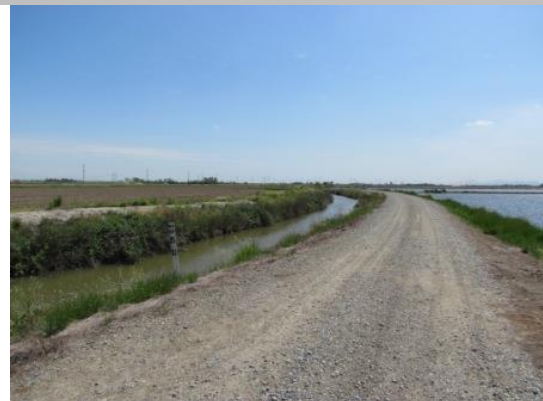
Photo 1 of 1 : FA_2015_MA0013_301_911_20150910_00019.jpg

LM Start	4.04	Rating **	M	Issue No.	911
LM End	4.78	Issue Type +	En	Location *	WS
Category	Earthen Levee			GPS Latitude/Longitude	
				Start	End
Item	Encroachments			39.526653 °	39.534091 °
				-121.699675 °	-121.690404 °
DWR ID	DWR_MA0013_02_s_2012_911				
Action/Comments					
Ditch

View of agricultural ditch along the toe.

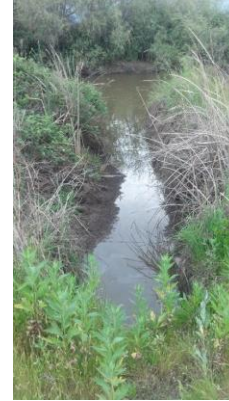
Photo 1 of 3 : UCIP_FA_2015_5151.jpg

View of channel at crossing.

Action/Comments					
<p>Inspector Comments: FS_ID:46212 DS_ID:16395 EP_NO: N/A FS_HLM: 5.063 Repair Type: Non-Urgent Crossing Status: Found UCIP Comments: 6/30/2015 Erosion on LS does not appear to be getting any worse with the rip-rap there. WS pipe end and gate appeared in good condition. Rusted pipe debris located on WS. Remove pipe debris on WS and monitor the LS erosion near headwall. Rip-rap used to protect LS headwall from erosion. Was pipe exposed prior to dumping rock? Erosion on the LS could have exposed pipe. Dense shrub on the LS could restrict flow. 7/9/2013 Same as last inspection. 12/9/2013 Same as last inspection. 5/29/2014 Same as last inspection. FIELD_STRUCT_DESC: 30-inch corrugated metal pipe through the levee, 8.6 feet below the crown. Flap gate on the waterward end. Concrete "U" headwalls on both ends (USACE-1960). This entry matches the Drainage or Irrigation Structure referenced in O&M manual (HLM 5.06). FS Date: 07/16/2015</p>

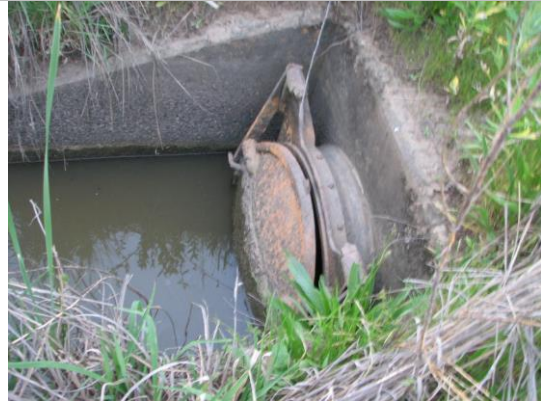
Photo 2 of 3 : UCIP_FA_2015_5152.jpg

Action/Comments					
Inspector Comments: FS_ID:46212					
DS_ID:16395					
EP_NO: N/A					
FS_HLM: 5.063					
Repair Type: Non-Urgent					
Crossing Status: Found					
UCIP Comments: 6/30/2015 Erosion on LS does not appear to be getting any worse with the rip-rap there. WS pipe end and gate appeared in good condition. Rusted pipe debris located on WS. Remove pipe debris on WS and monitor the LS erosion near headwall. Rip-rap used to protect LS headwall from erosion. Was pipe exposed prior to dumping rock? Erosion on the LS could have exposed pipe. Dense shrub on the LS could restrict flow. 7/9/2013 Same as last inspection. 12/9/2013 Same as last inspection. 5/29/2014 Same as last inspection.					
FIELD_STRUCT_DESC: 30-inch corrugated metal pipe through the levee, 8.6 feet below the crown. Flap gate on the waterward end. Concrete "U" headwalls on both ends (USACE-1960). This entry matches the Drainage or Irrigation Structure referenced in O&M manual (HLM 5.06).

Headwall and flap gate located on water side of levee

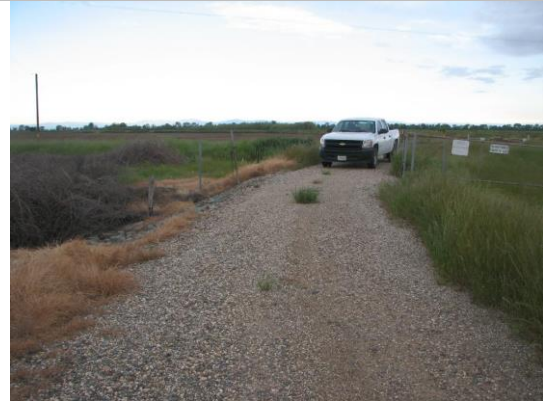
Photo 3 of 3 : UCIP_FA_2015_5153.jpg

Action/Comments					
Inspector Comments: FS_ID:46212					
DS_ID:16395					
EP_NO: N/A					
FS_HLM: 5.063					
Repair Type: Non-Urgent					
Crossing Status: Found					
UCIP Comments: 6/30/2015 Erosion on LS does not appear to be getting any worse with the rip-rap there. WS pipe end and gate appeared in good condition. Rusted pipe debris located on WS. Remove pipe debris on WS and monitor the LS erosion near headwall. Rip-rap used to protect LS headwall from erosion. Was pipe exposed prior to dumping rock? Erosion on the LS could have exposed pipe. Dense shrub on the LS could restrict flow. 7/9/2013 Same as last inspection. 12/9/2013 Same as last inspection. 5/29/2014 Same as last inspection.					
FIELD_STRUCT_DESC: 30-inch corrugated metal pipe through the levee, 8.6 feet below the crown. Flap gate on the waterward end. Concrete "U" headwalls on both ends (USACE-1960). This entry matches the Drainage or Irrigation Structure referenced in O&M manual (HLM 5.06).

Overview looking west on the left levee of Cottonwood

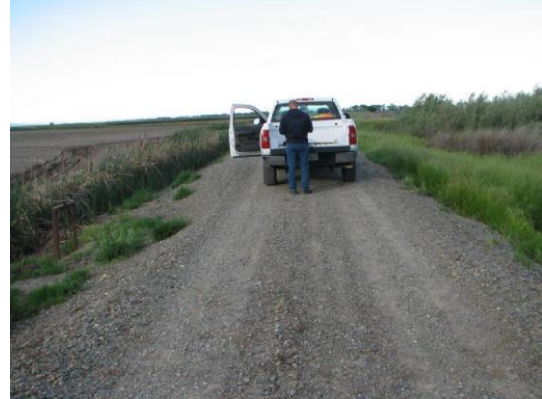
Photo 1 of 3 : UCIP_FA_2015_5281.jpg

Action/Comments					
Inspector Comments: FS_ID:46217					
DS_ID:16409					
EP_NO: N/A					
FS_HLM: 5.34					
Repair Type: Non-Urgent					
Crossing Status: Found					
UCIP Comments: 6/30/2015 WS flap gate was still overgrown with vegetation. Needs to be cleared away. Limited inspection on WS slope due to dense vegetation. Need photo of clear WS slope during next inspection. This crossing was listed in the USACE Periodic Inspection report as Corp's inspect ID#					
USACE_CESPK_M13H_2011_p_0035 non-functional crossing due to overgrown vegetation on WS flap gate. 7/9/2013 Same as last inspection. 12/9/2013 Same as last inspection. 5/29/2014 Same as last inspection.					
FIELD_STRUCT_DESC: 30-inch corrugated metal pipe through the levee, 5.8 feet below the crown. Flap gate on the waterward side. Slide gate on the landward side. Concrete "U" headwalls on both ends (USACE-1960). This entry matches the Drainage or Irrigation Structure referenced in O&M manual (HLM 5.34).

Overview of crossing looking downstream.

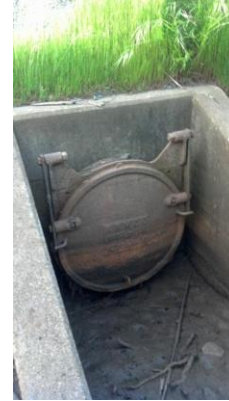
Photo 2 of 3 : UCIP_FA_2015_5282.jpg

Action/Comments					
Inspector Comments: FS_ID:46217 DS_ID:16409 EP_NO: N/A FS_HLM: 5.34 Repair Type: Non-Urgent Crossing Status: Found UCIP Comments: 6/30/2015 WS flap gate was still overgrown with vegetation. Needs to be cleared away. Limited inspection on WS slope due to dense vegetation. Need photo of clear WS slope during next inspection. This crossing was listed in the USACE Periodic Inspection report as Corp's inspect ID# USACE_CESPK_M13H_2011_p_0035 non-functional crossing due to overgrown vegetation on WS flap gate. 7/9/2013 Same as last inspection. 12/9/2013 Same as last inspection. 5/29/2014 Same as last inspection. FIELD_STRUCT_DESC: 30-inch corrugated metal pipe through the levee, 5.8 feet below the crown. Flap gate on the waterward side. Slide gate on the landward side. Concrete "U" headwalls on both ends (USACE-1960). This entry matches the Drainage or Irrigation Structure referenced in O&M manual (HLM 5.34). FS Date: 07/16/2015

Headwall and flap gate located on water side of levee

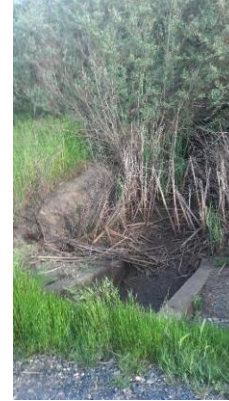
Photo 3 of 3 : UCIP_FA_2015_5283.jpg

Action/Comments					
<p>Inspector Comments: FS_ID:46217 DS_ID:16409 EP_NO: N/A FS_HLM: 5.34 Repair Type: Non-Urgent Crossing Status: Found UCIP Comments: 6/30/2015 WS flap gate was still overgrown with vegetation. Needs to be cleared away. Limited inspection on WS slope due to dense vegetation. Need photo of clear WS slope during next inspection. This crossing was listed in the USACE Periodic Inspection report as Corp's inspect ID# USACE_CESPK_M13H_2011_p_0035 non-functional crossing due to overgrown vegetation on WS flap gate. 7/9/2013 Same as last inspection. 12/9/2013 Same as last inspection. 5/29/2014 Same as last inspection. FIELD_STRUCT_DESC: 30-inch corrugated metal pipe through the levee, 5.8 feet below the crown. Flap gate on the waterward side. Slide gate on the landward side. Concrete "U" headwalls on both ends (USACE-1960). This entry matches the Drainage or Irrigation Structure referenced in O&M manual (HLM 5.34). FS Date: 07/16/2015</p>

View of WS headwall with dense vegetation in channel.

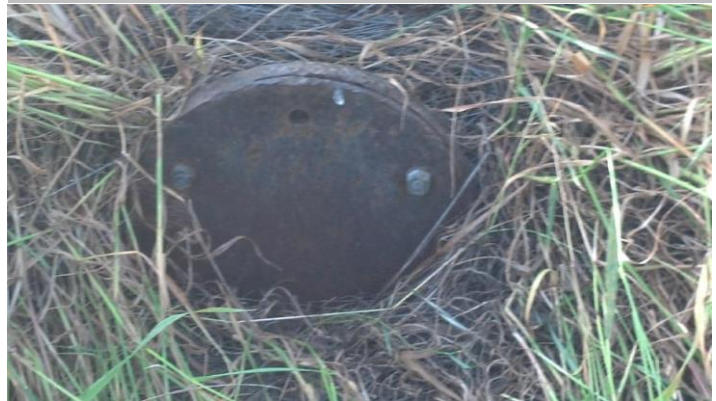
Photo 1 of 2 : UCIP_FA_2015_5284.jpg

Action/Comments					
Inspector Comments: FS_ID:46218 DS_ID:16410 EP_NO: N/A FS_HLM: 5.404 Repair Type: Non-Urgent Crossing Status: Found UCIP Comments: 6/30/2015 Pipe still present with the cap on the waterside. Limited inspection on WS and LS slope due to dense vegetation. Need photos of clear slopes during next inspection. Metal plate bolted on pipe for closure on WS, open on LS. 7/9/2013 Same as last inspection. 12/9/2013 Same as last inspection. 5/29/2014 Same as last inspection. FIELD_STRUCT_DESC: 6-inch steel pipe through the levee, 1.6 feet below the crown. Plate bolted on the waterward end. Open on the landward end. (USACE-1962) This entry matches the Drainage or Irrigation Structure referenced in O&M manual (HLM 5.41). FS Date: 07/16/2015

Capped irrigation pipe located on water side of levee

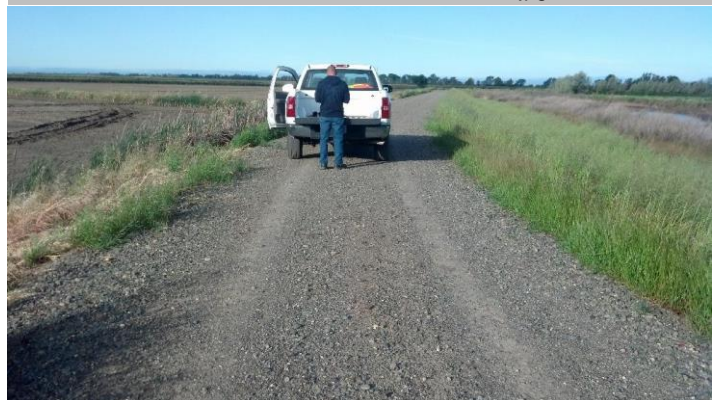
Photo 2 of 2 : UCIP_FA_2015_5285.jpg

Overview of site
